FACILITY COMPLIANCE INSPECTION REPORT

Division of Waste Management Solid Waste Section

Waste Industries LLC - Stone Park Court Transfer Facility
 148 Stone Park Court
 Durham, NC 27703

Comprehensive Audit

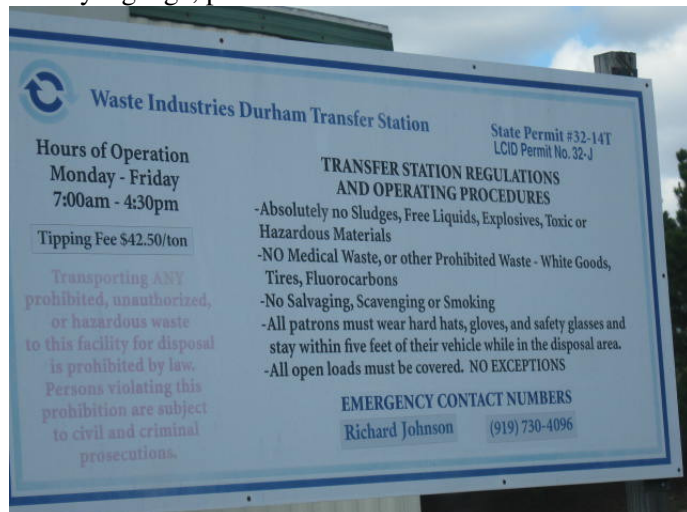
26. The facility has proper signage.
27. The permit expiration date is October 8, 2015.
28. Permit renewal application shall be submitted to the SWS by April 8, 2015.

Facility signage, prior to scale house

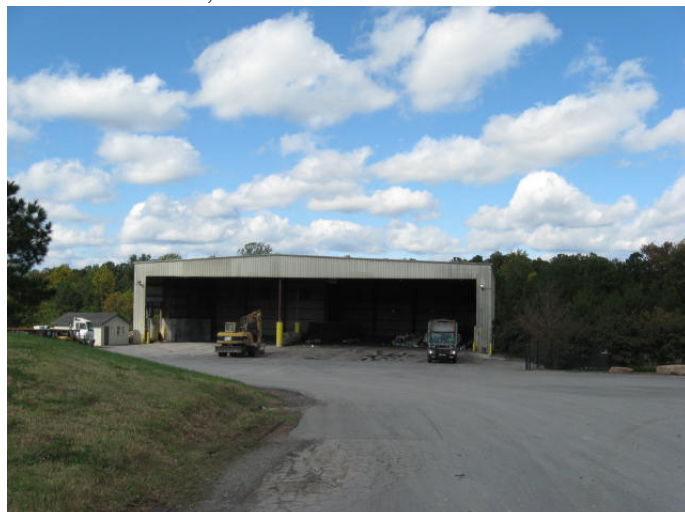
21. The transfer station (building) appeared to be in good repair.
22. There appeared to be no build-up of residue on the floor, walls, or ceiling of the transfer station.

Transfer station, view from access road

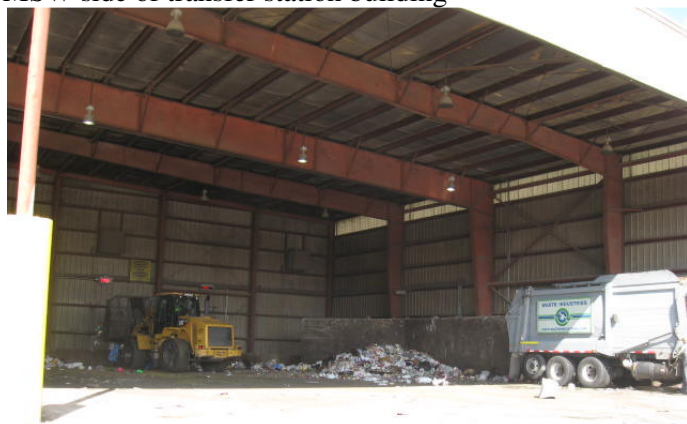
8. The transfer station has two receiving sections. The tipping floor is divided by cement push-wall into two halves. One side receives MSW and the other receives C&D. LCID is separated-out and placed in dumpsters, stored adjacent to the transfer station building. Cardboard and scrap metal are separated-out from waste received. Cardboard is placed adjacent to the transfer station building, baled, and stored until hauled off site to Sonoco Recycling, Inc. Scrap metal is stored in metal boxes until shipped-out.

MSW side of transfer station building

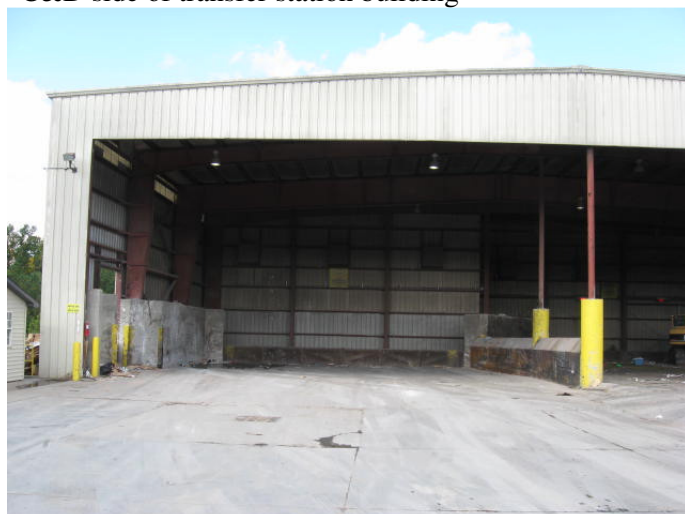
C&D side of transfer station building

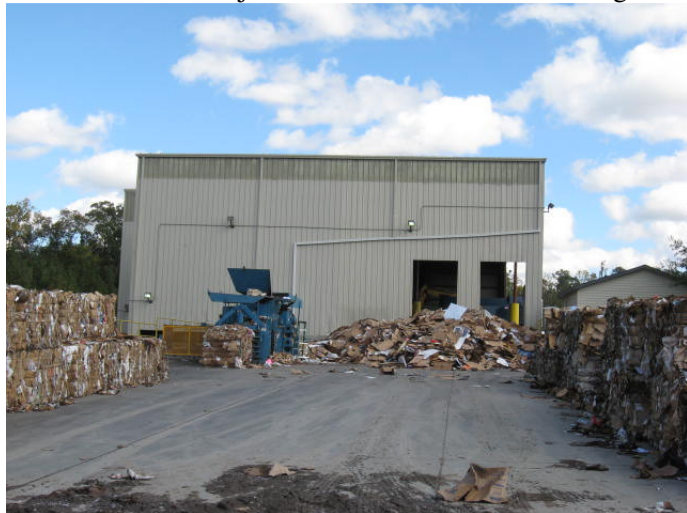
Cardboard stored adjacent to transfer station building

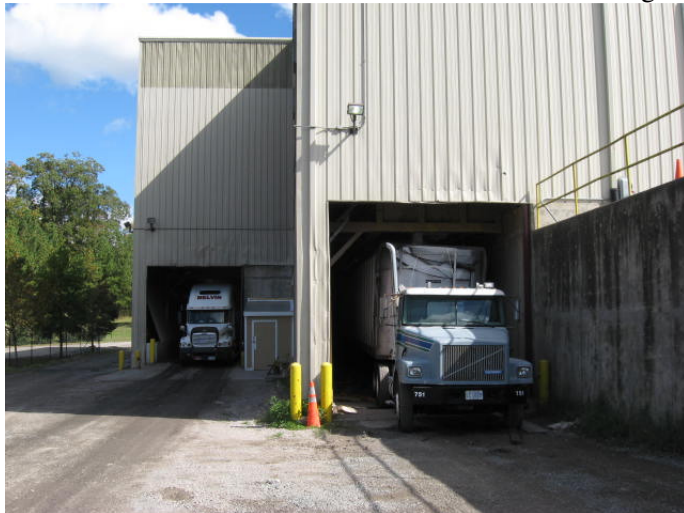
Truck load out area, at rear of transfer station building

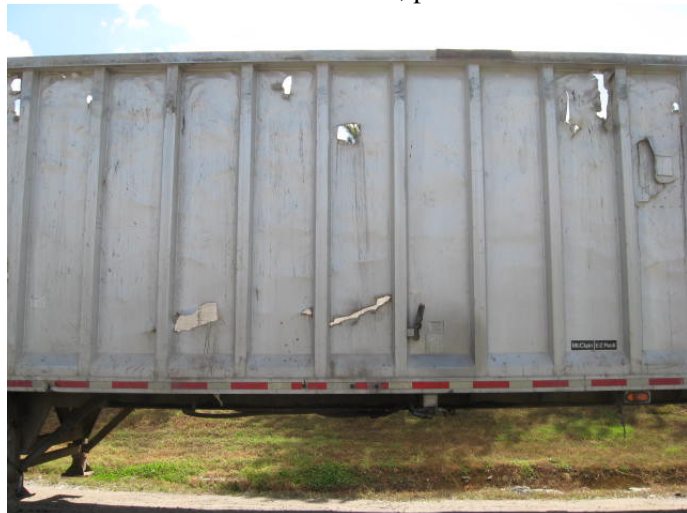
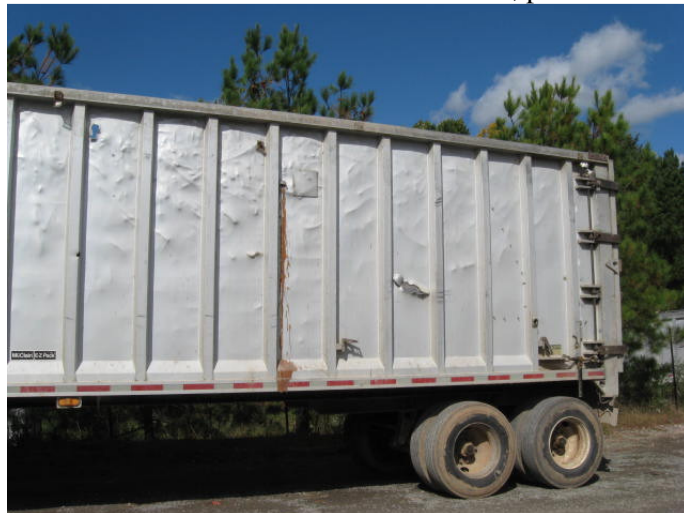
17. Several First Tee Transport, Inc. transfer trailers had numerous holes torn in their sheet metal sides. Mr. Davidson was asked to ensure that First Tee Transport, Inc. is contacted regarding the maintenance of the transfer trailers serving the facility.

Holes in sidewall of transfer trailer, pic No. 1

Holes in sidewall of transfer trailer, pic No. 2
